# Review of Aviation Accidents Caused by Wind Shear and Identification Methods

Wen-Lin Guan<sup>1</sup>, Kay Yong<sup>2</sup>

## ABSTRACT

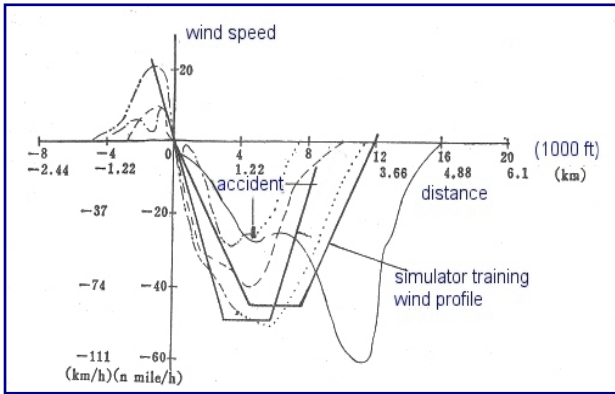
In 1975's Boeing 727 aircraft accident investigation, Fujita (1981) attributed the low-level wind shear as the cause of the accident, and an in-depth discussion on physics phenomena, space and time scale of atmospheric turbulence was presented. In 1997, ICAO formally established Low-Level Wind Shear and Turbulence Group. Its task is to circulate studies from various countries, and to formulate low-level wind shear related documents. In November 1980, the USAF amended the Military Specification on Flying Qualities of Piloted Aircraft (MIL-F-8785C), with the purpose of specifying the effects of turbulence on flying qualities of piloted aircraft (USAF, 1980). In 1981, NASA and FAA jointly promoted the project of Joint Airports Weather Study (JAWS), which focused on flying skills, flight training, and the evaluation of the low-level wind shear alert system (Woodsfield and Wood, 1983). Figure 1 shows a National Transportation Safety Board (NTSB) compiled wind speed profiles (dotted and actual lines) of wind shear related accident, which was obtained from flight data recorder (FDR). JAWS research pointed out that wind speed surrounded the accident from 6,000 ft to 12,000 ft

changed up to 70 knots. The ladder shaped curve is wind speed profile used in flight simulators as suggested by FAA.

Fig.1. Wind speed profiles (dotted and actual lines) of wind shear related accident, obtained from flight data recorder (FDR), and used in flight simulators. ( Source: FAA Advisory Circular, AC 00-54. Subject: Pilot Wind-Shear Guide, 1985 )

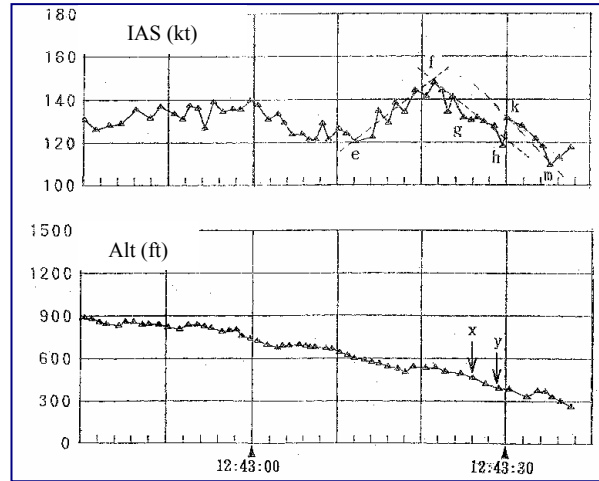
In April 1993, a McDonald DC-9-41 took off from Nagoya. About local time 12:44, the flight landed hard on runway 02 at Hanamaki Airport (Aviation Accident Investigation Commission of Japan, 1993). The aircraft suffered serious damage caused by impact fire. One crew and two passengers injured. The probable cause of this accident was identified as the aircraft was under severe wind speed and changing wind direction. The pilot continued approach without sufficient awareness of wind shear; and the aircraft encountered severe wind shear and suddenly sank when passing through the runway threshold. The investigation conducted the wind shear analysis by using the airspeed variation method of ICAO Circular 186. According to the variation of indicated airspeed (IAS) and pressure altitude, it was found that the aircraft encountered two severe wind shears in less than 500 feet. The metal foil based flight data recorder of the accident aircraft recorded only 5 parameters. Figure 4 illustrated the variation of airspeed and altitude of flight data below 900 feet.

Fig.4. Variation of airspeed and altitude of flight data below 900 feet, DC-9-41 accident flight at Hanamaki Airport, Japan, 1994. ( Source: AAIC Accident Investigation Report, 94-6-JA8448, 1993 )

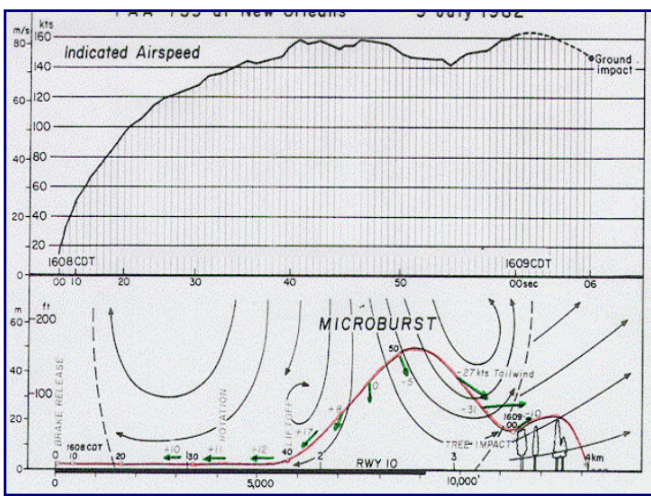
Figure 2 indicates the variety of microburst and airspeed of the accident in 1982 in New Orleans, and the aircraft encountered wind shear at 150 ft (altitude) after take-off. Accident investigation report shows the aircraft encountered downdraft from the microburst during ground taxiing and initial climb; due to the sharp loss of headwind, producing inadequate lift was produced, hence causing the crash of the aircraft.

Fig.2. Variety of microburst and airspeed of the accident in 1982 in New Orleans, the aircraft encountered wind shear at 150 ft (altitude) after take-off (red indicates flight path; green indicates direction of microburst).

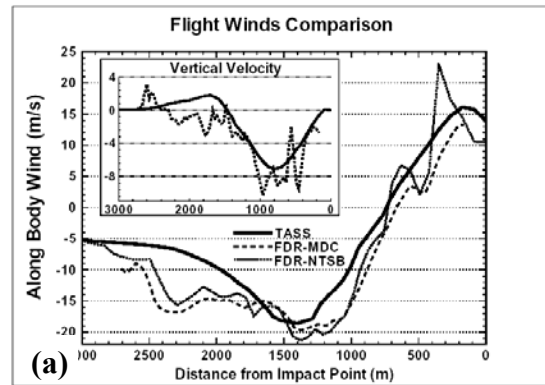
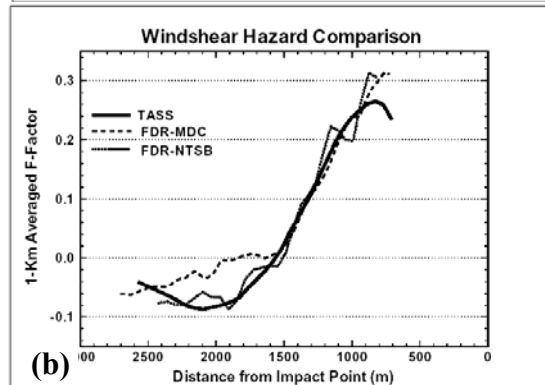
transports. On July 2, 1994, a DC-9 crashed at Charlotte-Douglas Municipal airport. NTSB and NASA conducted investigation. They used F-factor and found that the aircraft encountered severe wind shear during approach (FSF, 1996b). After the pilot decided to go around, the aircraft reached 2200 feet, then sank rapidly, and crashed at the west-north area 2000 ft away from runway 18 right. Figure 5a indicates the horizontal wind component (positive stands for tailwind) along the body axis and the vertical-wind component (positive stands for down wind) against the distance to the impact point. The headwind changed into tailwind (horizontal wind variation greater than 20 m/s) at the point about 1400 ft from the impact point. The vertical wind shear (down wind greater than 10 m/s) occurred as well. The ground based wind observation showed the headwind changed from 35 knots to tailwind of 26 knots within 14 seconds. Figure 5(b) depicts the 1-km averaged F-factor against the distance from the impact point. The F-factor rapidly changed from 0.1 to 0.25 between 1200 ft to 800 ft from the impact point.

Fig.5. Horizontal wind velocity (positive stands for tailwind) and vertical wind velocity (positive stands for down wind) against the distance from impact point (a). 1-km averaged F factor against the distance from impact point (b).

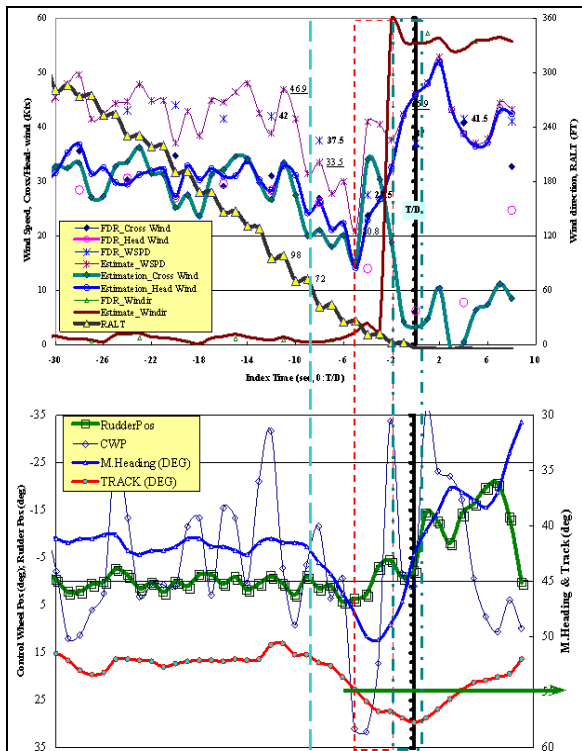
Figure 6 illustrates the time histories plots of FDR parameters (30 seconds before TD), and the wind versus radio altitude. Referring to Figure 6, before TD time, there are three major findings: (1) (30 seconds ~ 12 seconds), the average wind speed was 42 knots, and the wind direction varied from 5 degrees to 10 degrees; the draft angle 10 degrees, track angle of the aircraft 51 degrees, and the related 05L runway’s heading 53 degrees. (2) (11 seconds ~ 5 seconds), wind decreased rapidly, and the flight crew applied the rough control wheel (about 32 degrees) and light rudder. The flight crew intended to recover the horizontal deviation with runway of 05L. (3) (5 seconds ~ T/D), wind increased rapidly, the wind direction changed more than 57 degrees. The flight crew applied the light control wheel from right bank to left bank. In the meantime, the left-crosswind increased and then decreased more than 10 knots, and it caused difficulty in lateral control, and induced the aircraft’s track angle to 57 degrees. The pilot used 4 degrees crab angle to touchdown and that caused the aircraft slipped outside the surface of runway. Six seconds after TD, the flight crew applied the rough control wheel

and rudder control for left maneuver, and it caused the nose wheel on the surface of runway and both main landing gears outside the runway. At that time, the heading was 37 degrees (-16 degrees of crab angle).

Fig.6. Time history plots of FDR parameters for the last 30 seconds

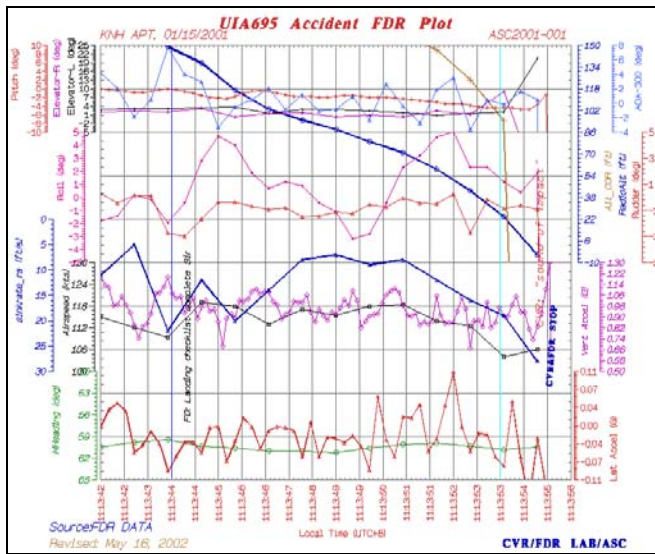
According to the FDR recorded- and derived- parameters, they are indication that the aircraft suffered downdraft three times below 250 ft. The relevant parameters presented at 171 ft (change of AOA=8 degrees, descent rate=30 ft/s), 137 ft (change of AOA=6 degrees, descent rate=11 ft/s), and 43 ft (change of AOA=7 degrees, descent rate=18 ft/s), respectively. Prior two seconds of TD, the descent rate increased from 16 ft/s to 28 ft/s. At this moment, the elevator was activated from 0 degree to 20 degrees, but the aircraft was still sinking with pitch-down attitude. Figure 7 illustrated the time history plots of FDR parameters for the last 300 ft, with UTC time shown on the abscissa, and parameters of radio altitude, descent rate, vertical acceleration, attitude angles, angle of attack, and elevator shown on ordinates.

Downdraft may increase the descent rate; it could be verified from vertical acceleration, vertical wind ( $V_{wind}$ , negative value is downward wind) and change of AOA (change of positive-AOA to negative-AOA is downward wind). In addition, using wind shear identification methods to analyze the last 250 ft, we found five sections affected by downdraft: (A) 261ft ~ 254ft, (B) 254 ft ~ 182ft, (C)182 ft ~ 149ft, (D)137ft ~ 103ft, and (E)59 ft ~ 24ft, respectively.

Fig.7. Time history plots of FDR parameters (below 300 ft)
