Aviation Safety Council

**GE222 Occurrence Investigation
Factual Data Collection
Group Report**

Survival Factors Group

ASC-FRP-14-12-07

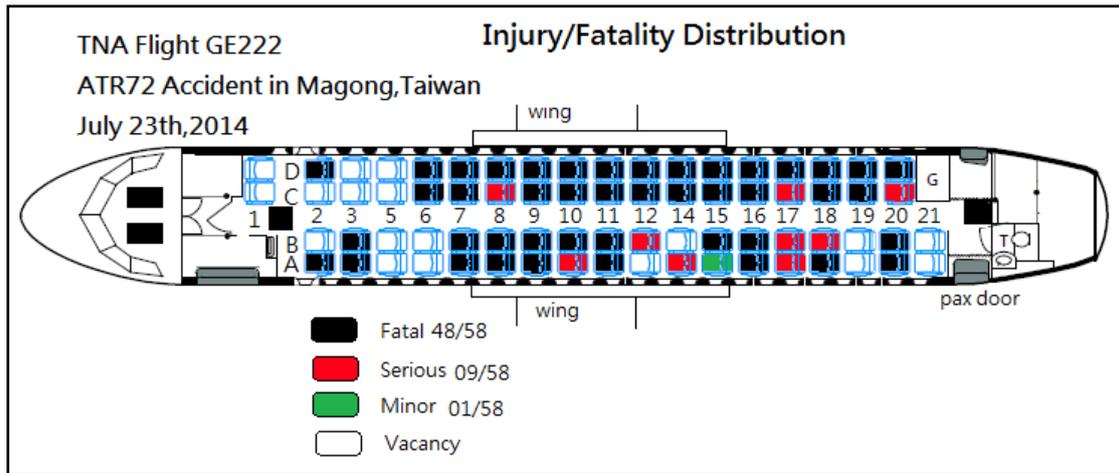
Figure 1.2-1 Injury and fatality distribution

Figure 1.2-1 shows passenger seat positions, the injury and fatality distribution. The information of the passenger seating positions is based on the airline seating plan and interview notes of the passengers. (Referred to Attachment 7-1)

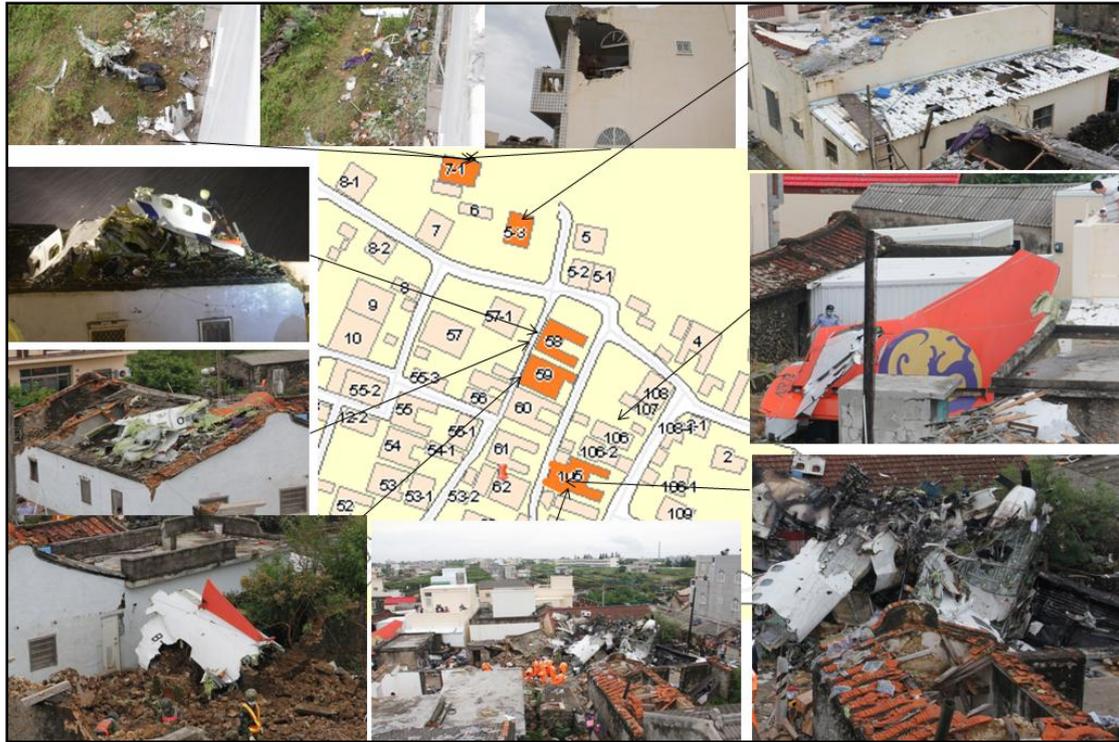
Figure 1.3-1 the distributions of wreckages and buildings

1. the right wing tip and the right landing gear rested next to building No.7-1, as shown on Figure 1.3-1;
2. the central and root section of the right wing rested on the roof of building No.5-3, as shown on Figure 1.3-1;

4. the rear section of the fuselage (frame station from 36 to 44) with part of the vertical wing root rested inside the No.59 building, as shown on Figure 1.3-1;

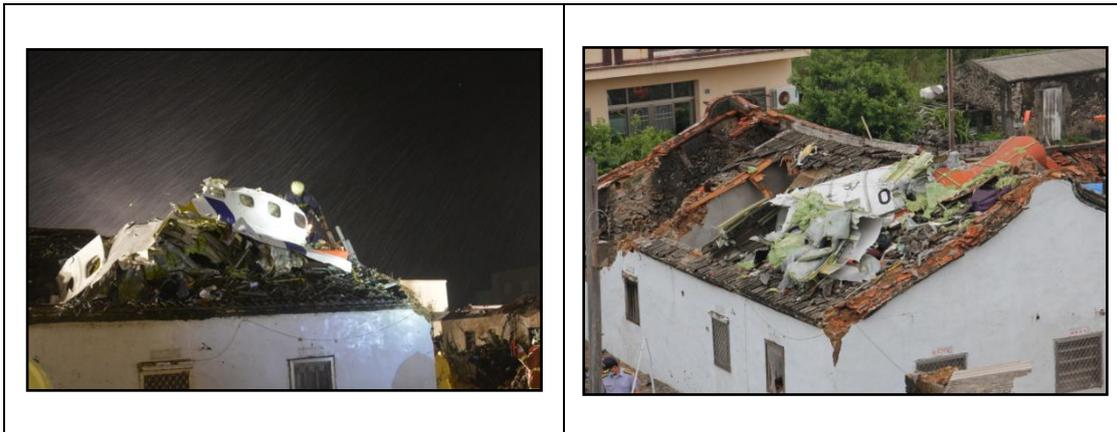
Figure 1.3-2 the rear section of the fuselage on the roof

3. the rear section of the fuselage (frame stations 31 to 35, 19 to 21 rows of passenger seats) rested on the roof of building No.58, as shown on Figure 1.3-2;(Refer to Attachment 7-2)

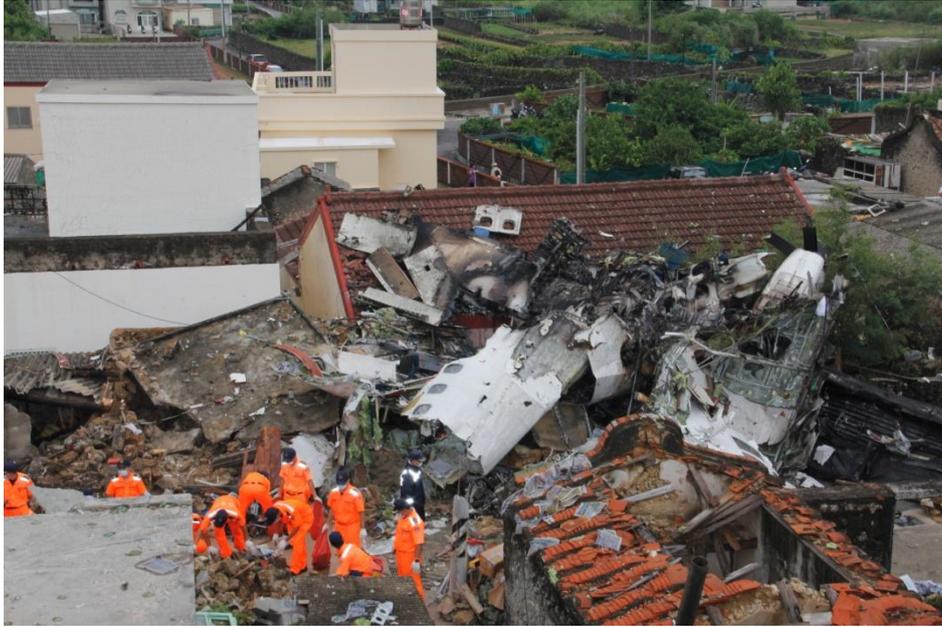
Figure 1.3-3 the front section of main wreckage on scene

5. the vertical wing rested next to building No.106, as shown on Figure 1.3-1;
6. the fuselage (frame stations 28A to 31, 14 to 19 rows of passenger seats) leaned to left which rested next to building No.105, and it broken from the front fuselage (from nose to frame station 28A, cockpit crew seats to 14 rows of passenger seats) which rested upside down. The No.1 power plant stood upward. The left wing turned upside down, as shown on Figure 1.3-3;
